Improved industry capacity for wastewater management by small wineries in the Margaret River wine region

Project report

Prepared for Winewatch by Genevieve Hanran-Smith
and Mark Gibberd

September 2009

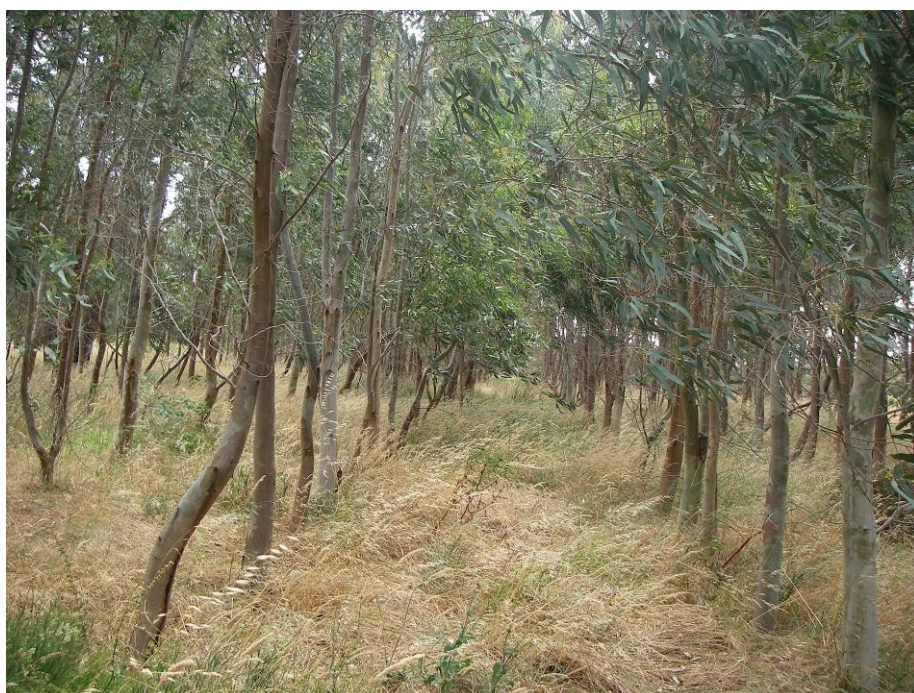
Figure 2: Irrigation site at Winery 1

A magnetic flow meter was installed in 2008 to measure wastewater volumes at the point of disposal.

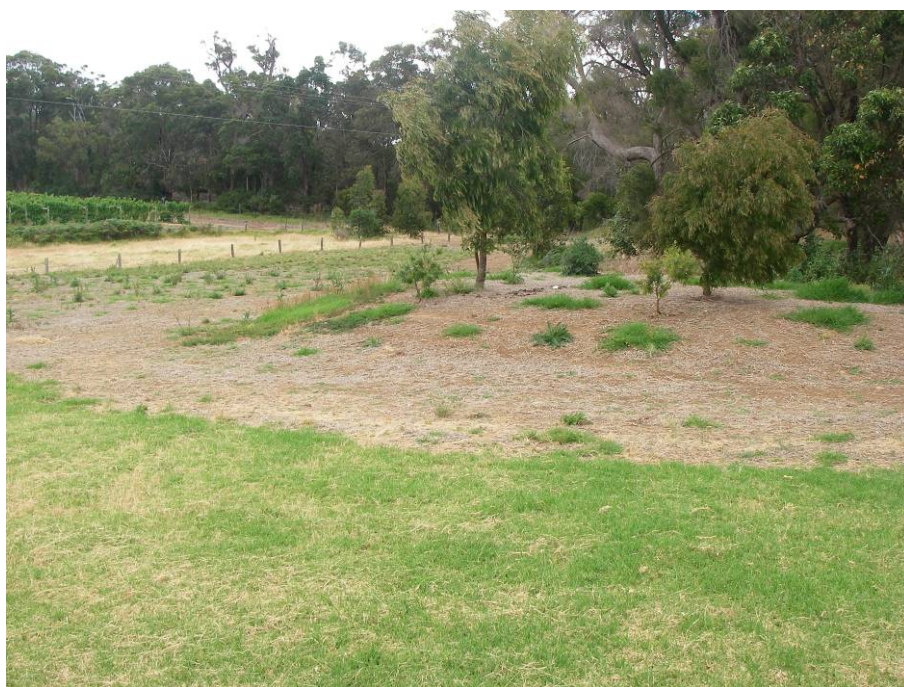
Figure 3: Subsurface disposal site at Winery 2

A magnetic flow meter was installed in 2008 to measure wastewater volumes at the point of disposal.

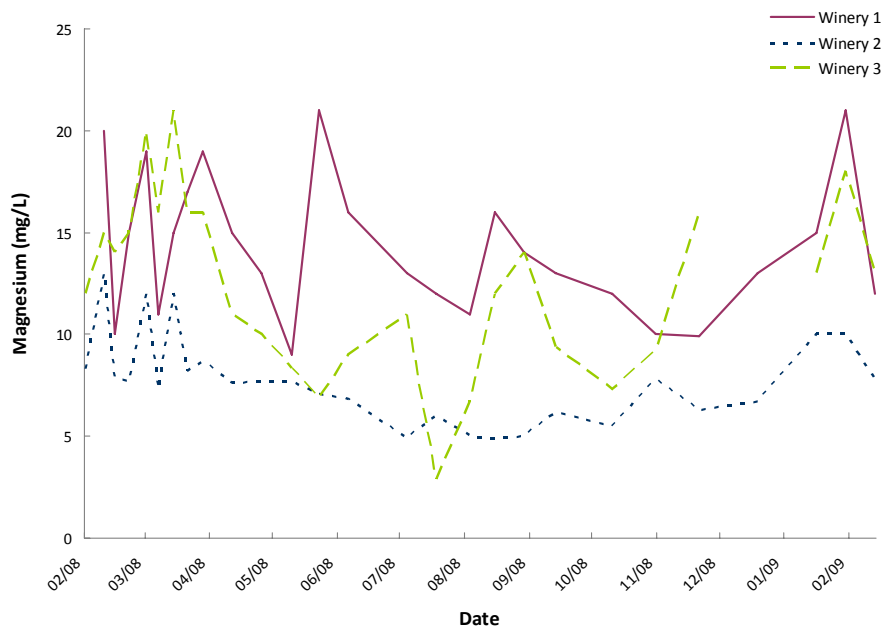
Figure 19: Magnesium in wastewater from three small wineries over 12 months

Figure 20: Magnesium in wastewater from three small wineries over 12 months (moving average)

The magnesium in the wastewater at the three wineries ranged from 2.9 mg/L to 21 mg/L. The mean vintage result for the three wineries was 13.3 mg/L and did not differ significantly from the mean non-vintage result of 10.3 mg/L. Winery 2 consistently had a lower result and less variation from the mean than the other two wineries (Figures 19 and 20).

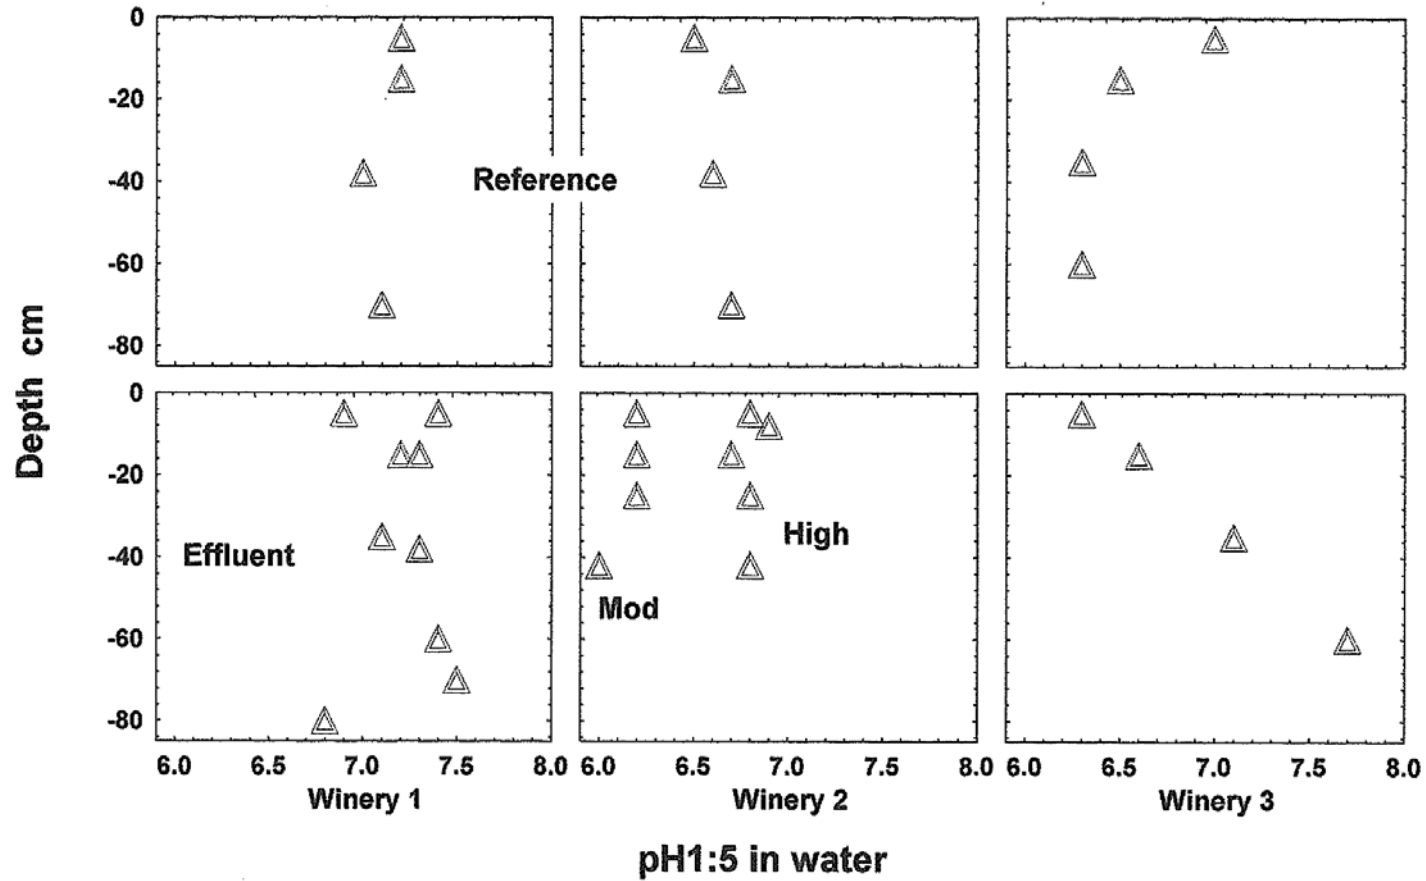
Fig. 1 Winery Effluent Project Profile pHw

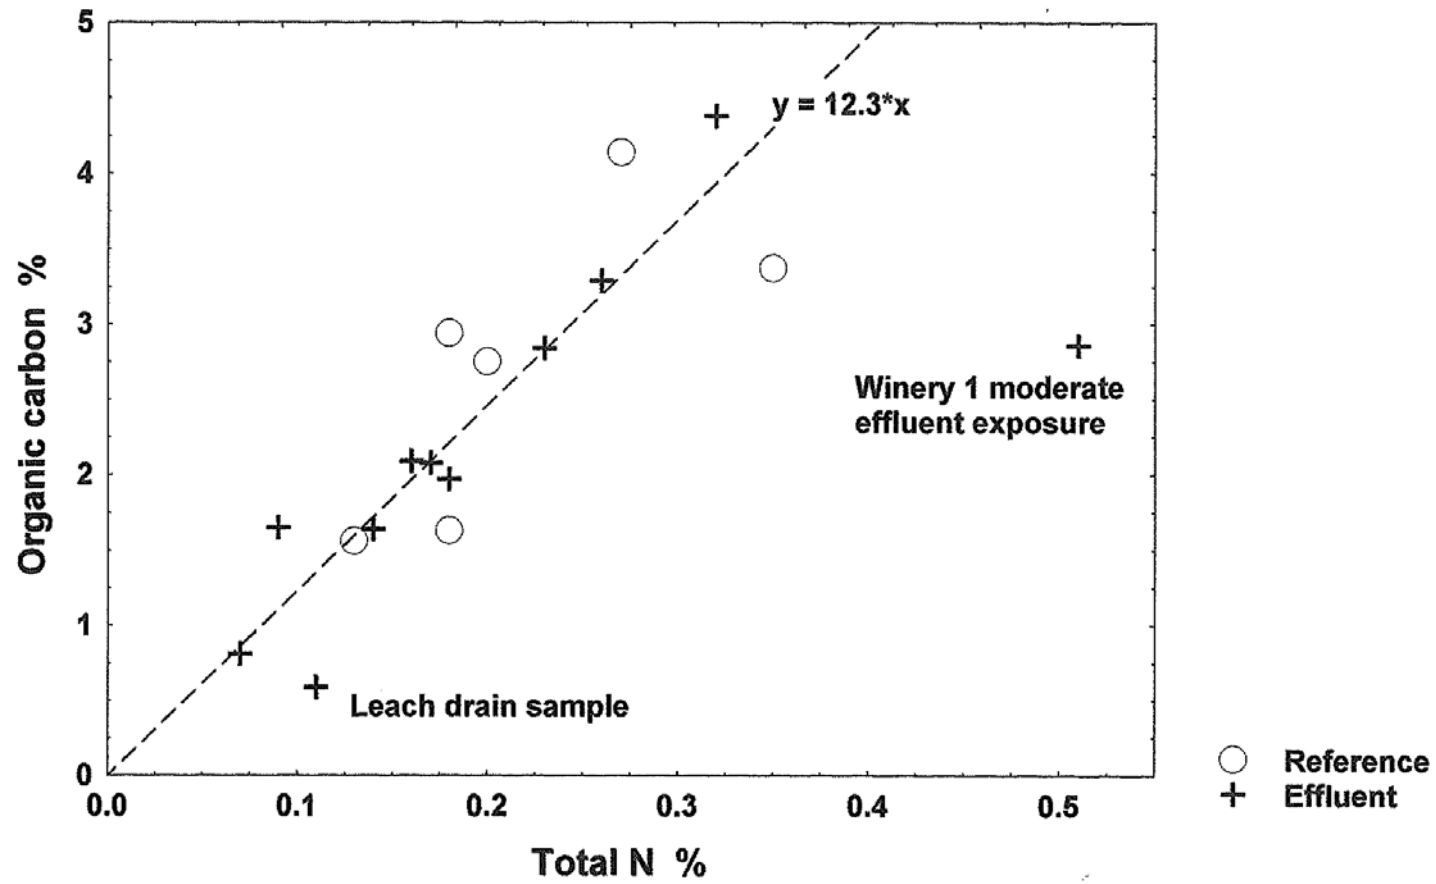
Fig 2. Winery Effluent Project Org C v Total N for topsoils

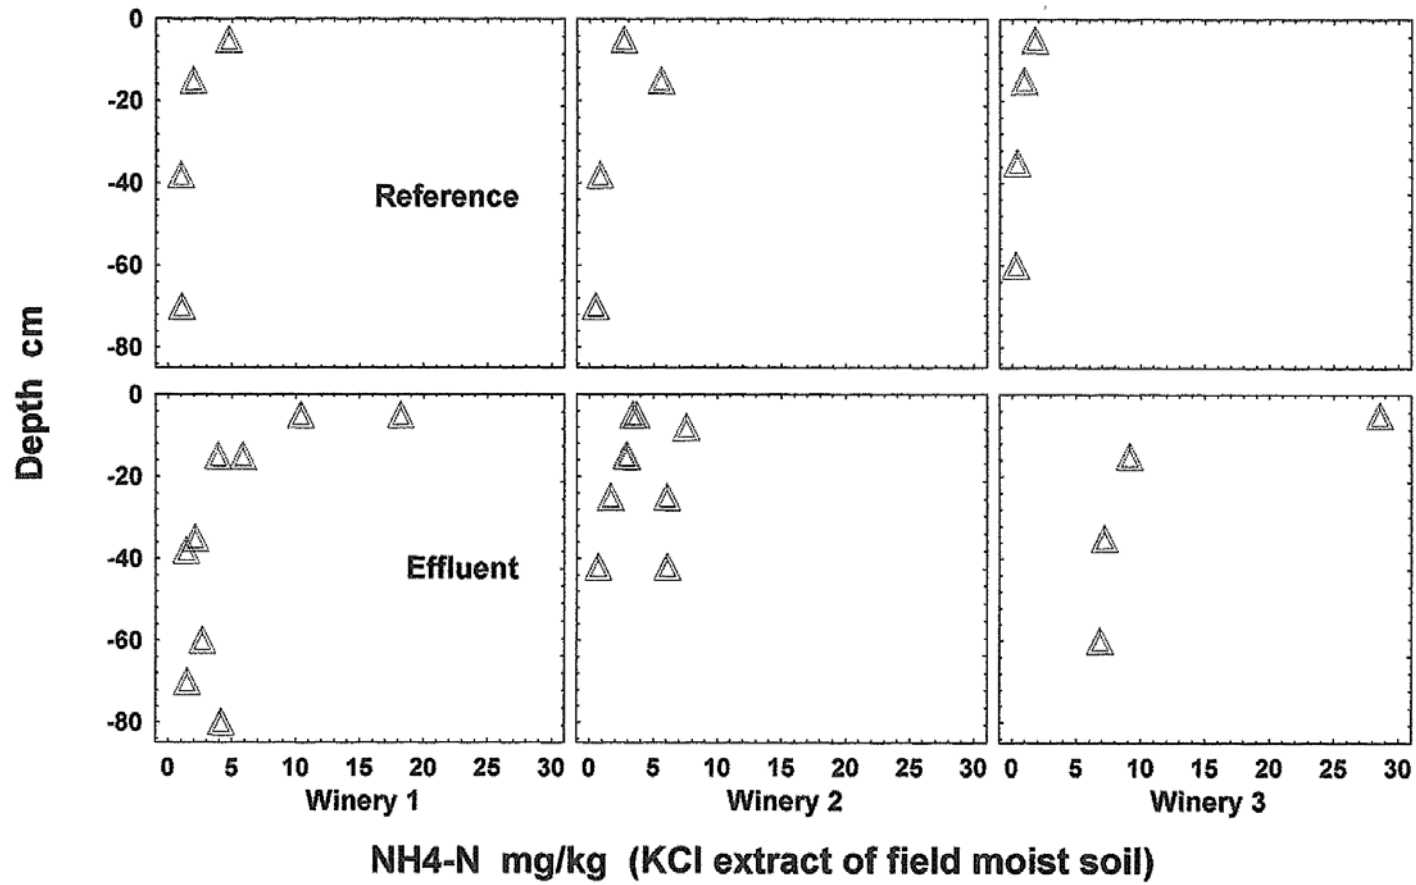
Fig 3 Winery Effluent Project Profile NH4-N

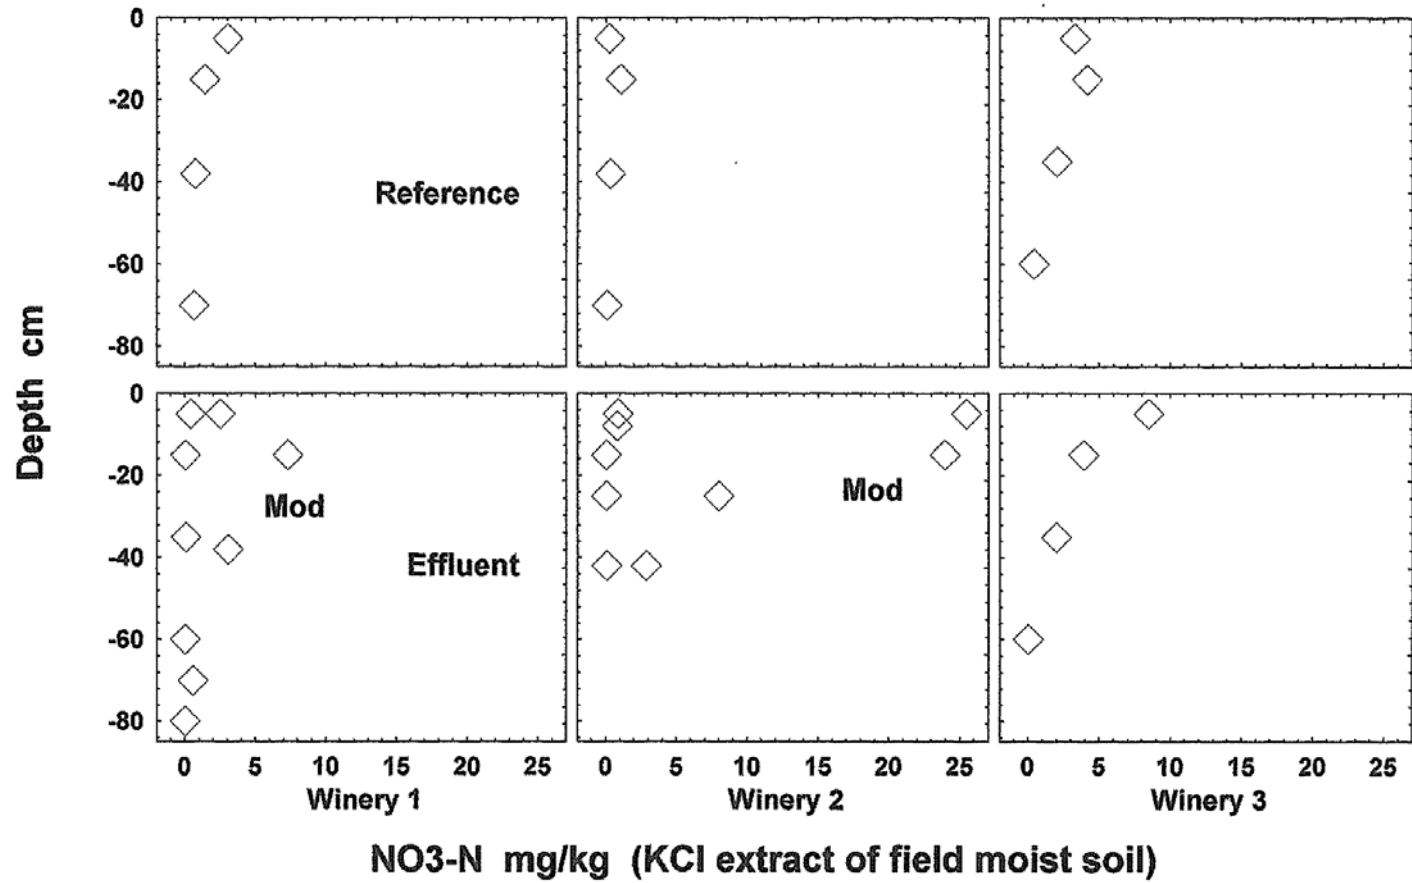
Fig 4 Winery Effluent Project Profile NO3-N

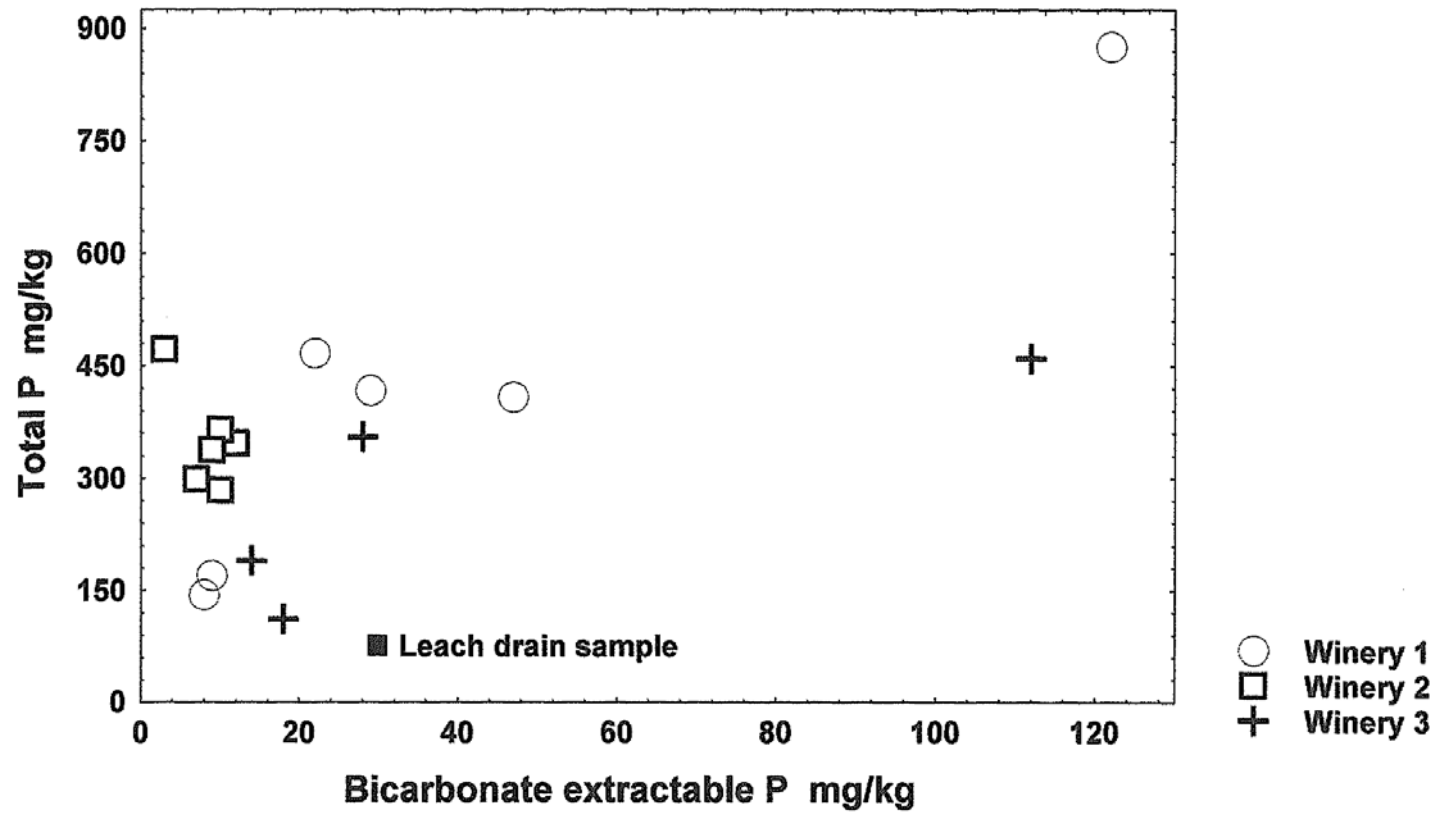
**Fig. 5 Winery Effluent Project Total P v Bic P
in topsoil samples**

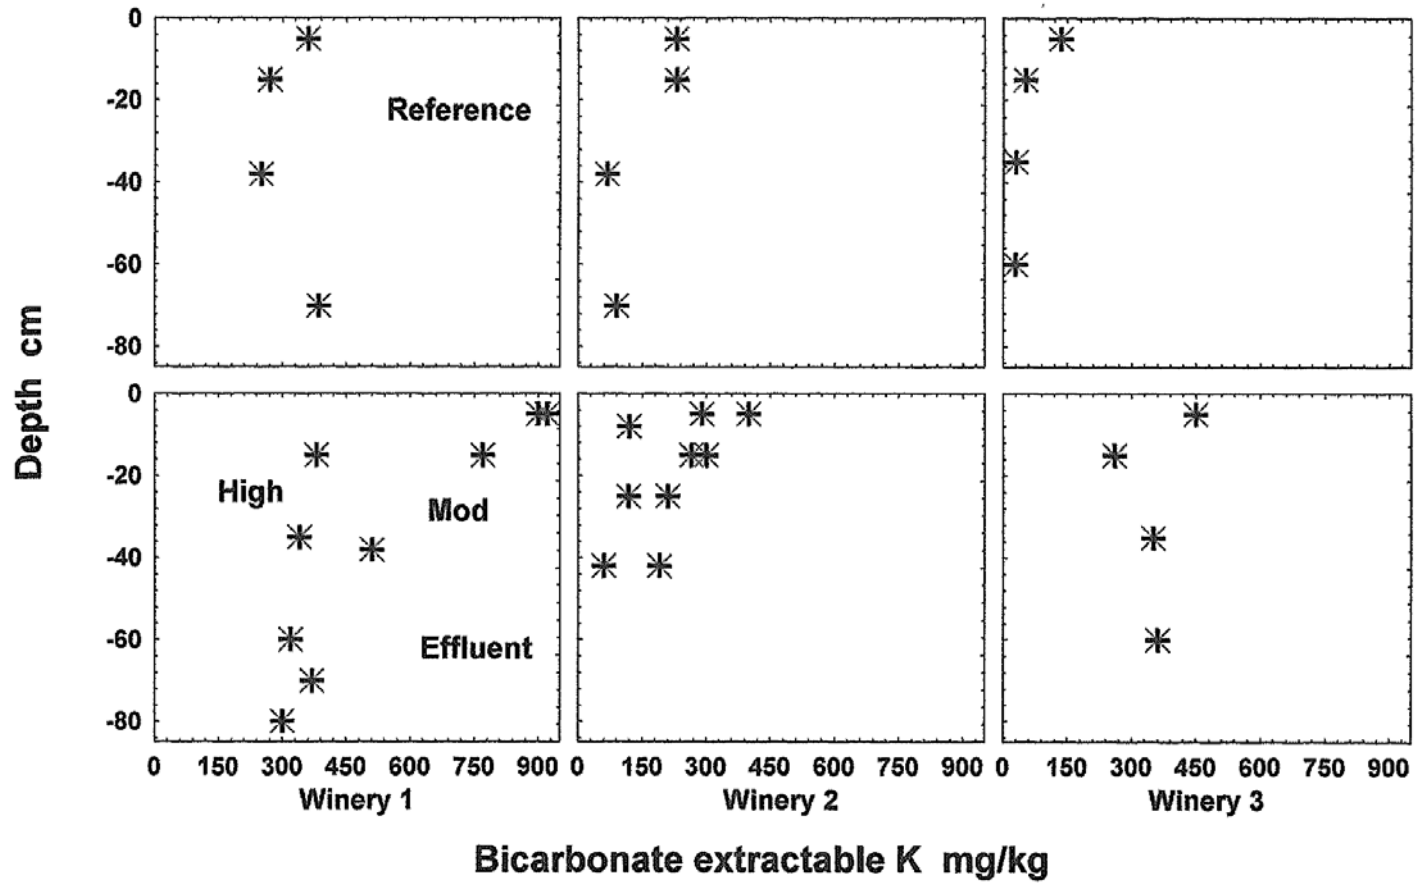
Fig. 6 Winery Effluent Project Profile Bic K

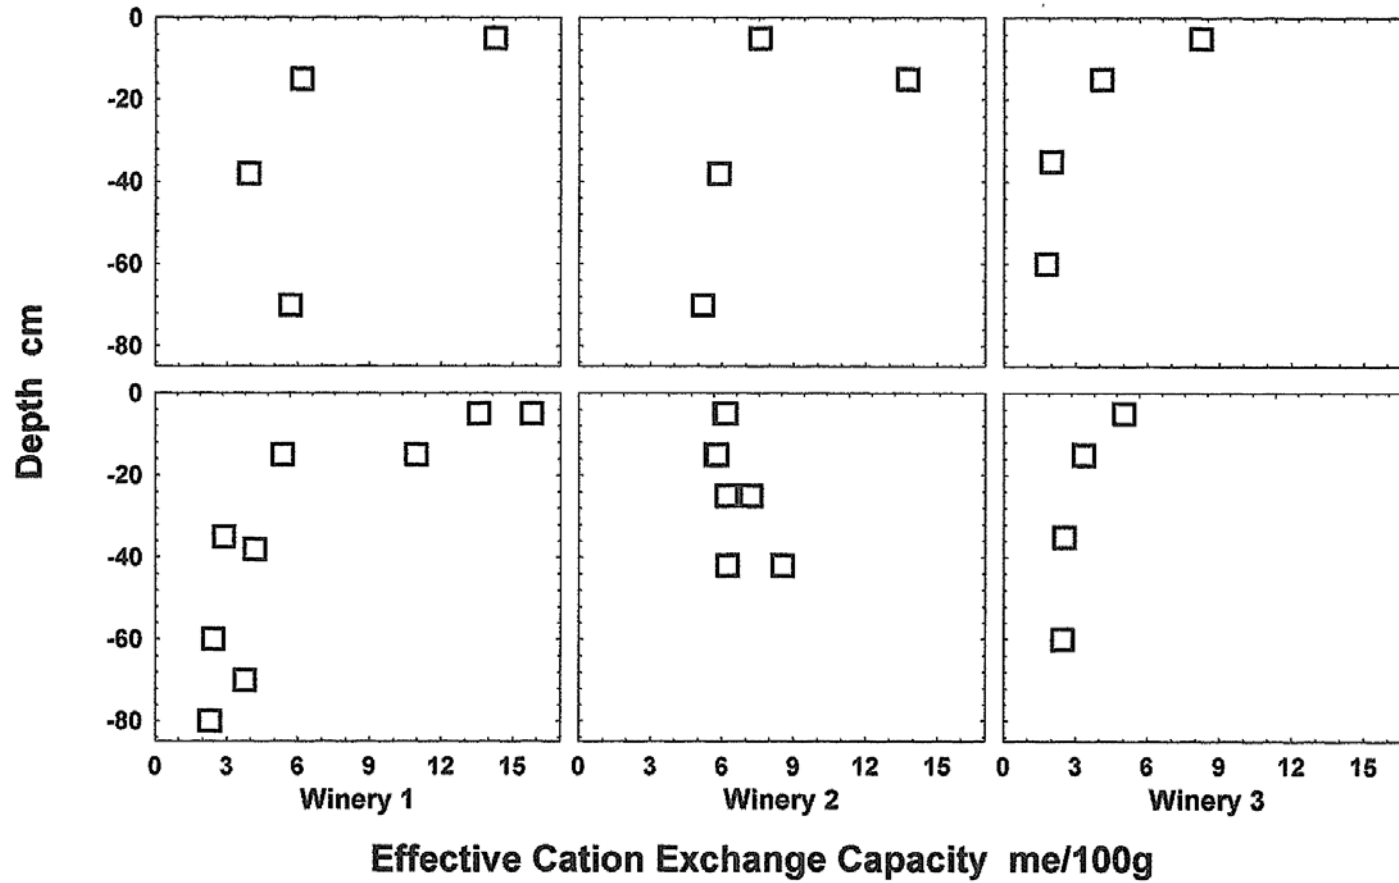
Fig. 7 Winery Effluent Project Profile Values of ECEC

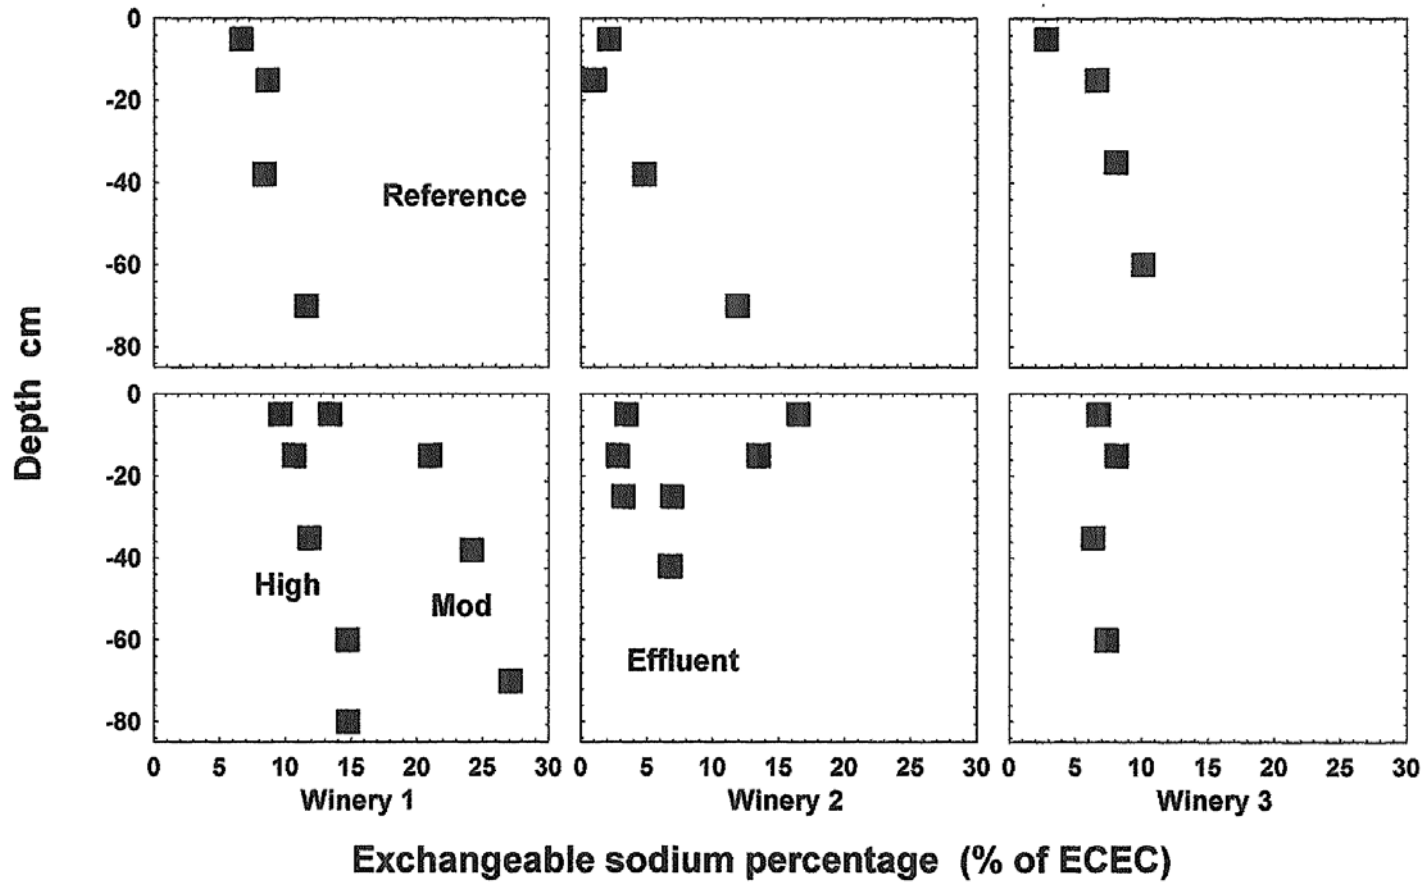
Fig. 8 Winery Effluent Project Profile ESP

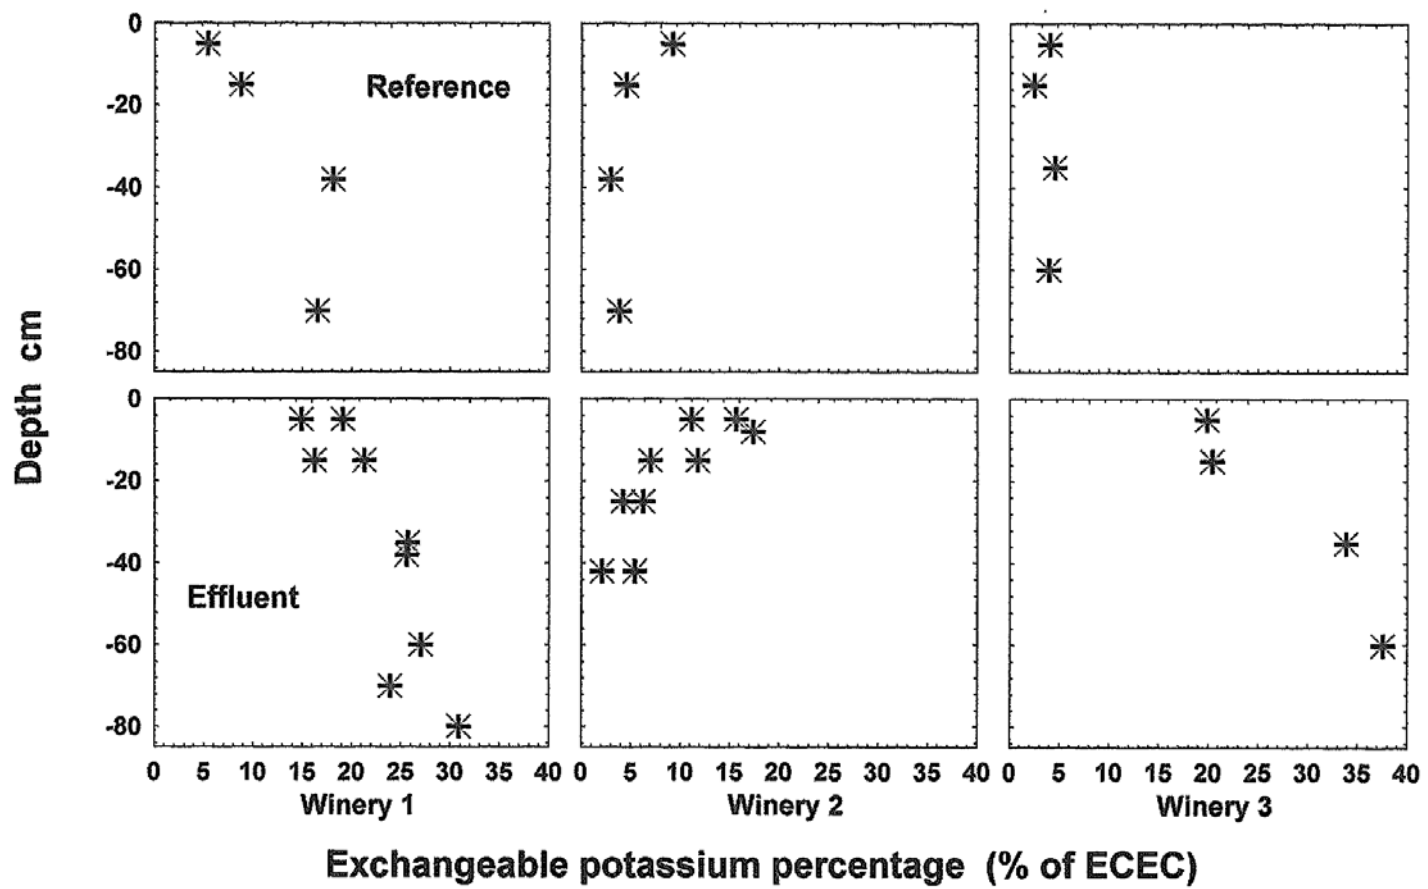
Fig. 9 Winery Effluent Project Profile EPP
